Subject: Greaseless Bushings in Skid-Lift Scissor Stack (All Models):

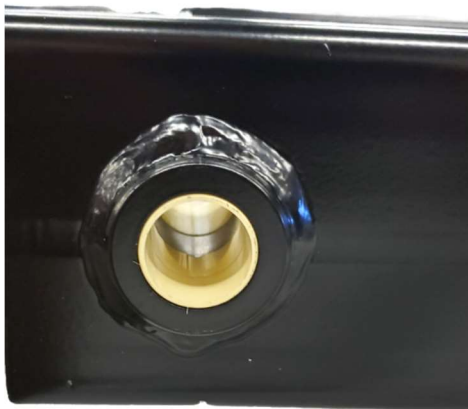
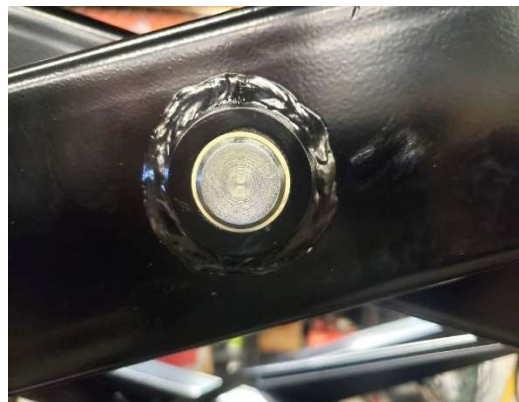
All current models of Skid-Lifts which include the 1505s, 1805s, 2306s, and 1908E HD lifts, the lifts have been outfitted with greaseless bushings. Along with this, all "s" model lifts have increased pin diameter sizes to further reduce the possibility of wear on the pins. This means there are no grease zerks in the scissor stack except for on each side of the hydraulic cylinders.

Here is a couple of photos to show the pin and greaseless bushing set-up:

Note: It is important that pins and bushings should still be inspected for wear or damage per the normal suggested maintenance schedule.

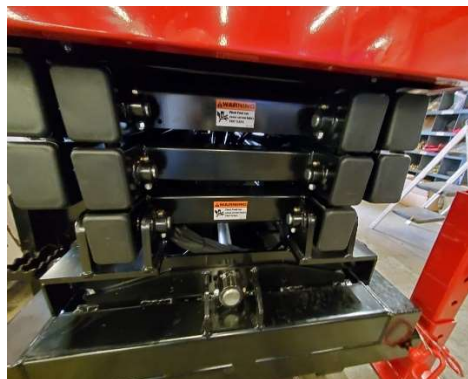
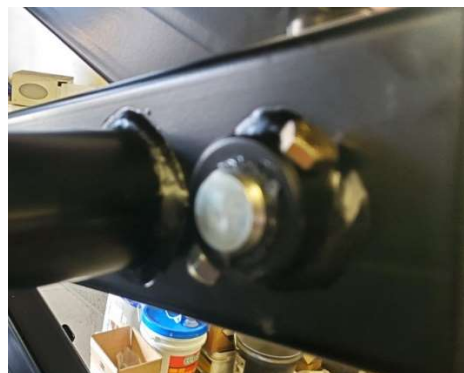
Along with the greaseless bushings, Skid-Lift has locked the pin from movement on the inner arms further reducing any possibility of wear of the inner arms. This means that pin rotates only on the wear bushings or the plastic slide blocks at the top of the bottom of the lift. This can be seen in the photos below:
